## **Performance Study of Irrigation Network in Renggung Irrigang Area, Lombok Central Regency**

**Restusari Evayanti**

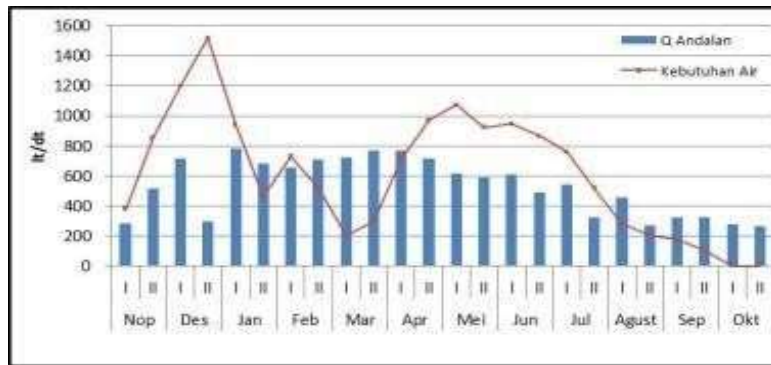
Figure 6. DI Water Balance Graph. Render Plan Conditions

PTT selection is based on the value of the K factor in each PTT scenario for one year. The PTT is selected by minimizing the occurrence of overruns in the trunk [12] [13]. Based on the results of the water balance analysis, it was obtained that the optimal initial planting period was November I and November II with an optimal K factor probability of 66.7%. However, early November I planting was chosen because it was in accordance with existing conditions.
